NORTH BERWICK GOLF CLUB

Provisional Assessment of Coastal Issues

Report date: 8 July 2014
Consultant: Bob Taylor

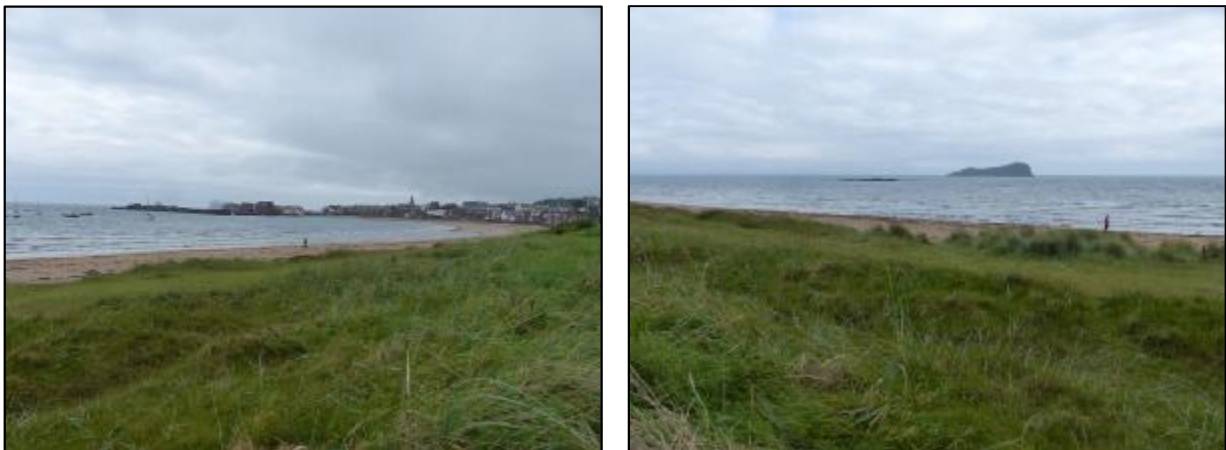
View east north east and north north east from the 1st tee

A strong tract of coastal vegetation extends to 22-25 m out from the 1st tee (out from the coastal edge), this section of the coastline is at least in part being protected by the vertical pylons installed from the town through to the golf course and also as a result of the rock platforms and islands offshore. The vegetation here is very strong dominated by red fescue with sea lime and marram.

Midway along the fairway the vegetation reduces to a nominal 10 m, this continuing over 120 m to the next rock outcrop.

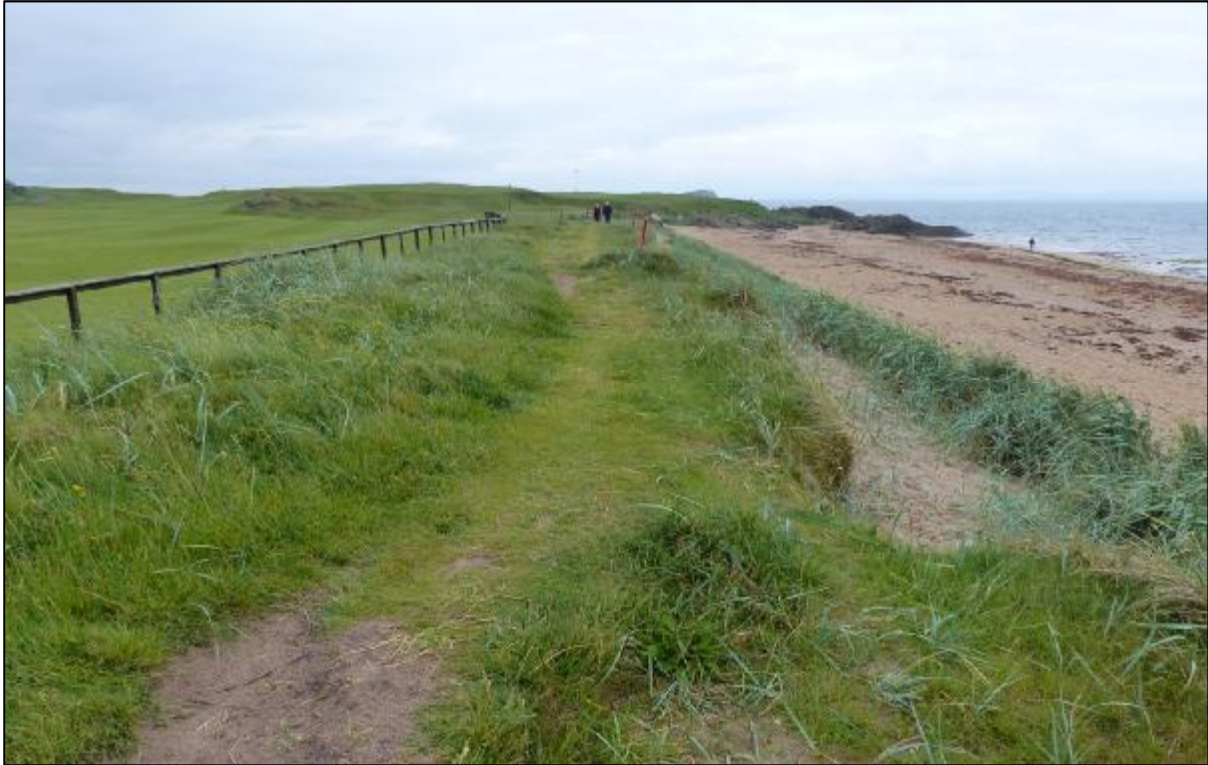
Vegetation interests noted through this section included ribwort plantain, bird's-foot trefoil, cat's-ear, rough hawkbit, upright bent, sand sedge and yarrow. As can be seen from the picture the dune height bordering the golf course extends to no more than 1-1.5 m leading to a possible risk of inundation during moderate to severe storm events.

Reducing vegetation and dune structure through fairway to green

Recommendation for management: To improve sand retention i.e. dune nourishment I strongly urge you to consider reinstating the series chestnut palings that are still evident at least in part through this section of the coastline. Introduce a series of 12 m long palings from the existing dune edge at 70° from the north with spurs connecting to the main run at 7 m running in a due north orientation. Space the main runs at 12 – 15 m and continue over the 120 m length to the rock outcrop to the right of the green. Do not connect any posts into the more established dunes. Use 3 m long posts and drive to 2 m into the base of the sand. Should this not be possible then it may be necessary to concrete the posts at a shallower depth to ensure stability.

The main runs will capture the sand being blown onto the course from a north east orientation; the spurs will capture any sand movement from the south east. Brash could be tied into the palings following any management of the sea-buckthorn or other scrub on the course. The brash will need to be tied in securely to reduce movement and/or flapping which would lead to further instability during storm events.

The presence of paling fencing will accelerate and improve short-term stabilisation.

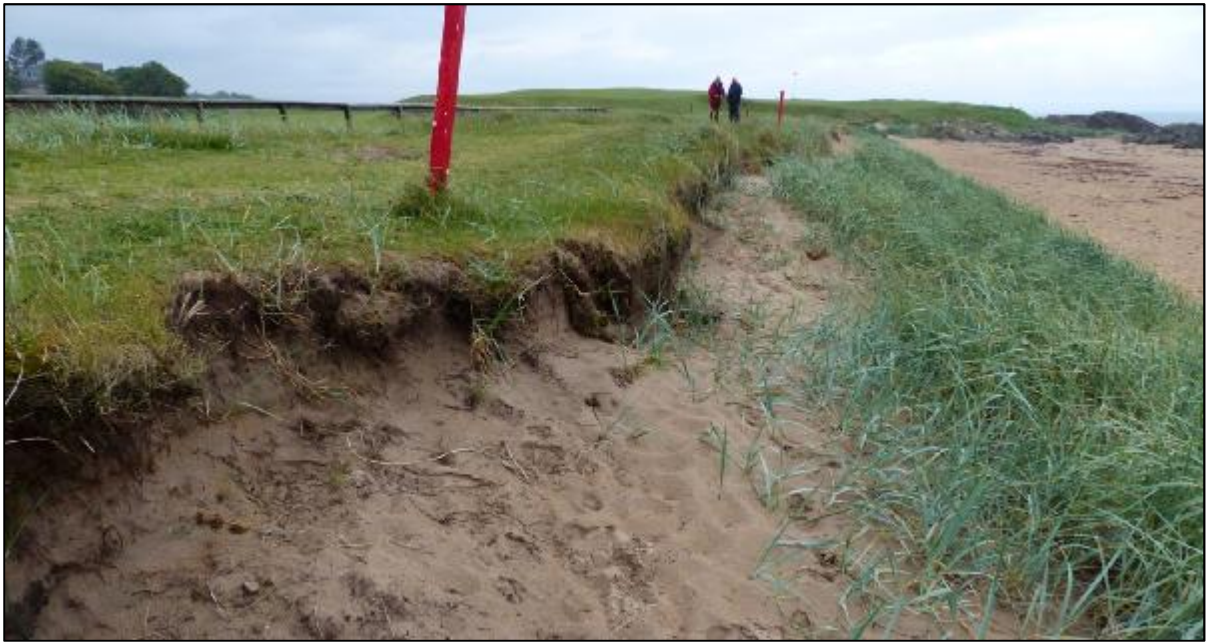
Sand capture and expansion of sea lyme

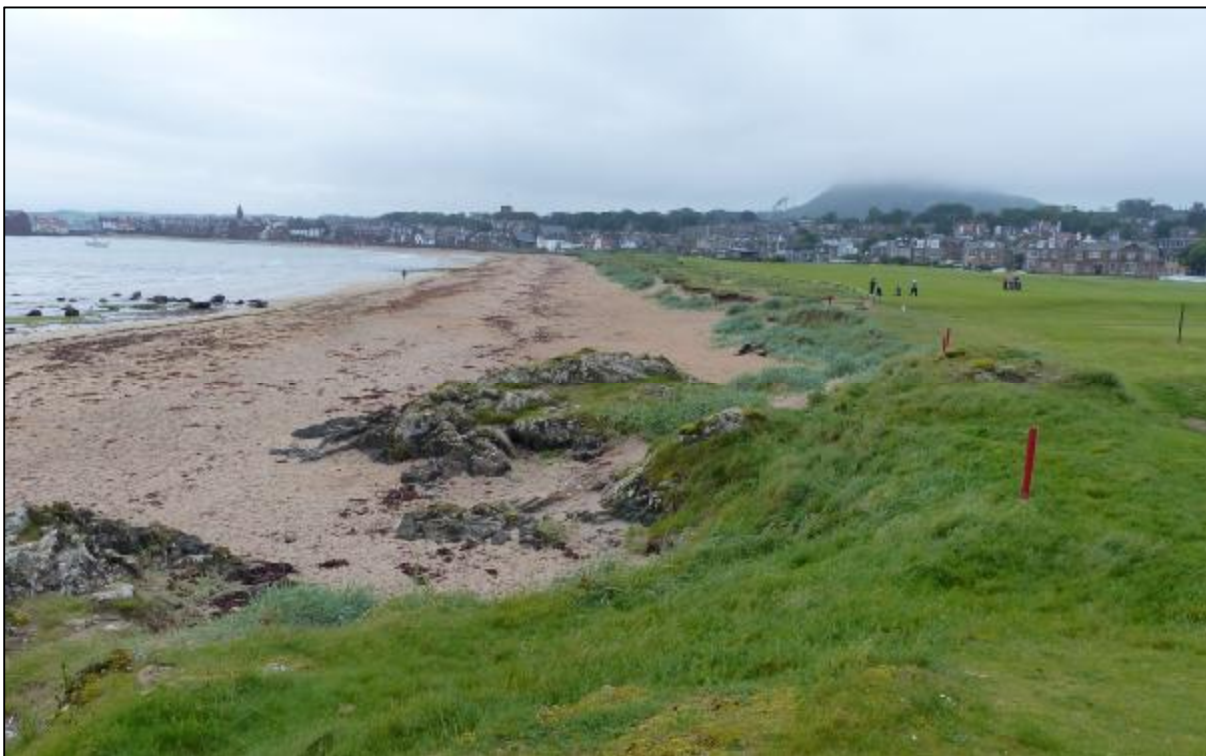
Looking back from the 1st green i.e. from the rock platform

The palings will need to be positioned as indicated so as not to be overly intrusive to visitor access.

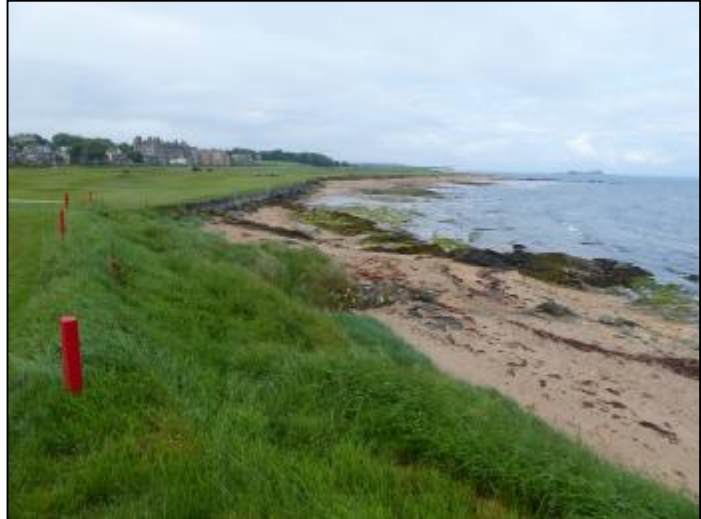
Eroding coastline – note changes in beach structure from sand to rock platform

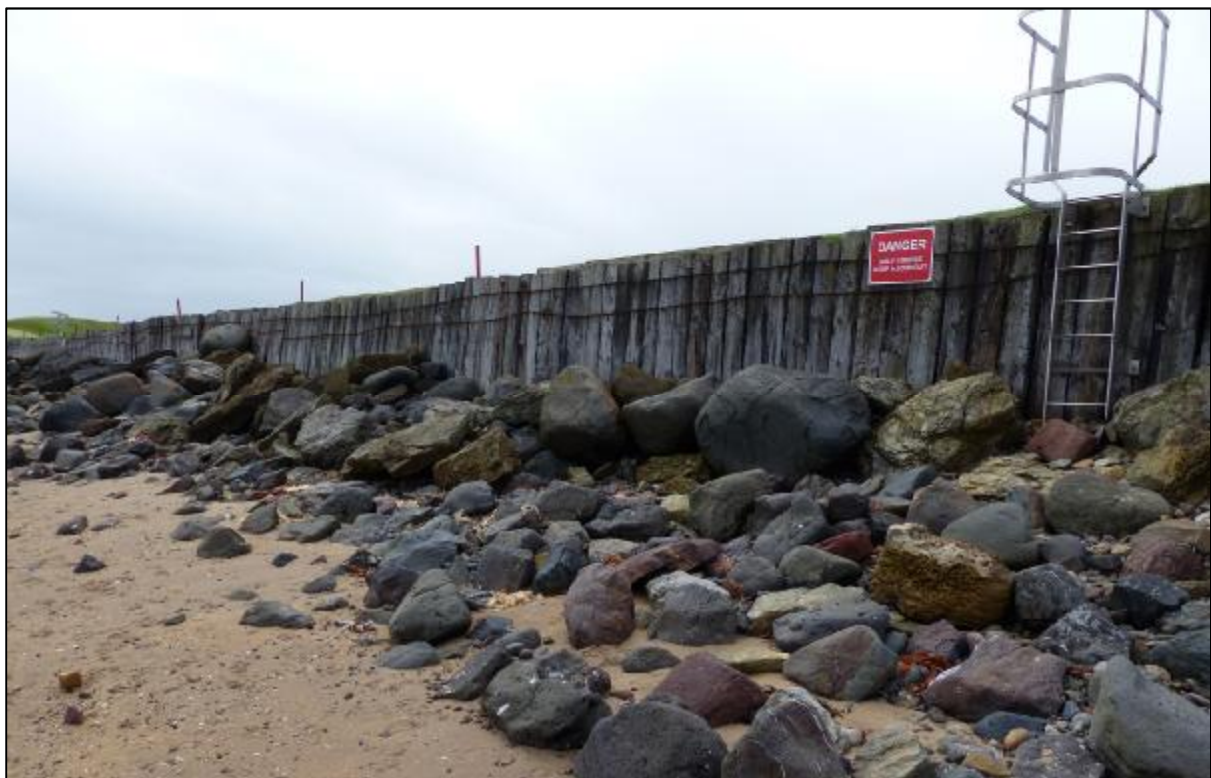
The 2nd carry is protected by a series of vertical sleepers which have held together well over the last 30 years since their introduction, one or two are however weakening. The rock armouring is also well represented the tees through to the carry but there placement is haphazard and fairly random in terms of their distribution. The protection here is neither sufficient in extent or formed with appropriate angle of repose to protect from stronger storm surges.

Vertical sleepered face and weak rock armouring protecting the 2nd tees and carry area

We agreed that the rock armouring should ideally be bolstered to create a shallow 15° angle of repose to encourage breaking of wave energy well before hitting the sleepered face. This would involve raising the rocks to almost the height of the sleepers and extending out by a further 4 m than existing.

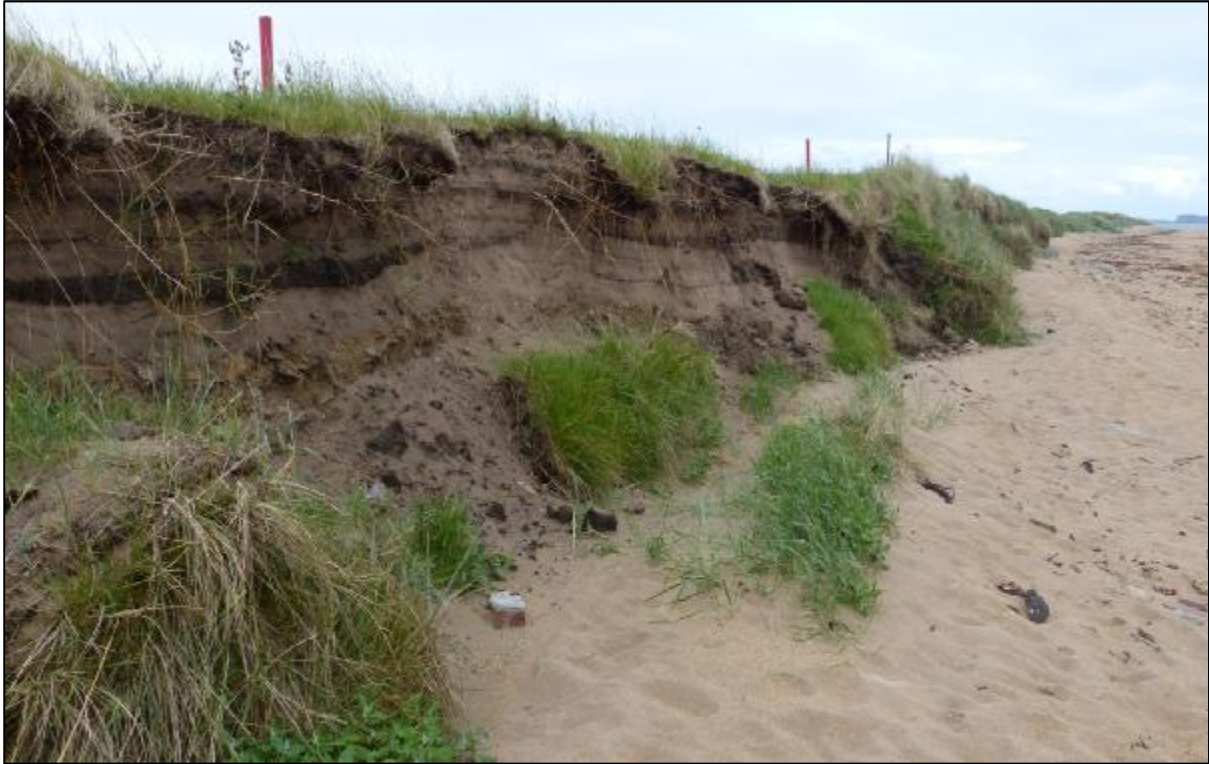
Eroding coastline from the fairway through to the green with local (short-term accretion)

Through the remainder of the 2nd hole consider chestnut paling fencing running at an acute angle - see above, then extended out by no more than 8 m to within 1 – 2 m of the general high water mark. This will leave sufficient access through the upper section of the shoreline during high tides, it does appear however that the majority of people do prefer walking on the more elevated dune sections.

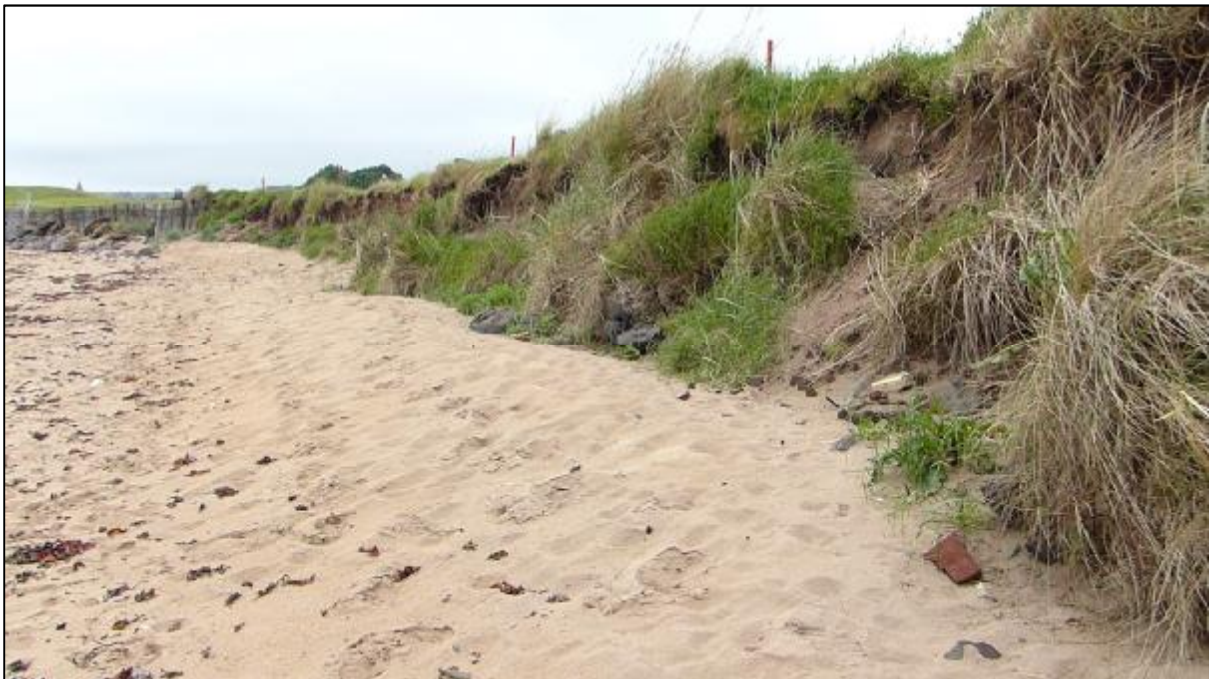
Looking back to 2nd tees – note short-term sand build up through the spring of 2014 only

It was encouraging to see significant sand accretion at the foot of the dune, though any stabilisation without the above intervention is likely to be constrained by regular foot traffic that is acute through certain sections.

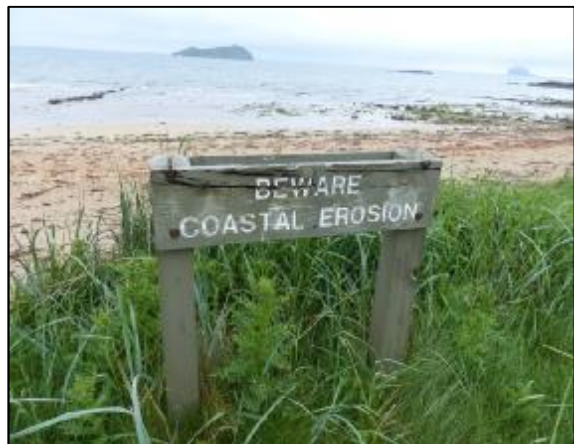
A good indication of erosion extent can be seen to the right of the 3rd tees as the coastline erosion signage was introduced approximately 3 m from the coastline 12-15 years ago, the signs are now within less than 1 m of the coastal edge (2-3 m loss over 12-15 years).

Coastal erosion sign 1 m from coastal edge

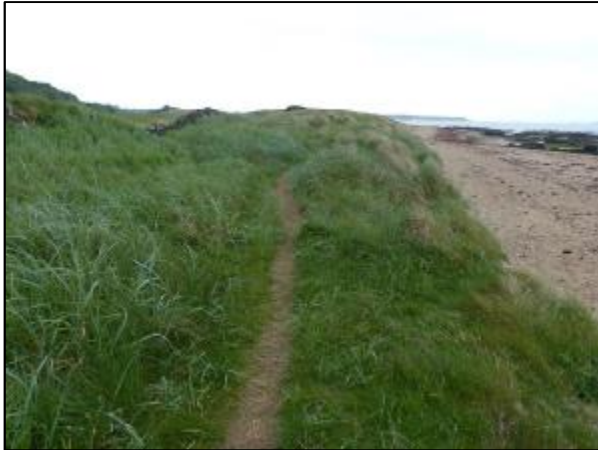
Significant accretion and good stability exists right of the 3rd green running through to the 14th point

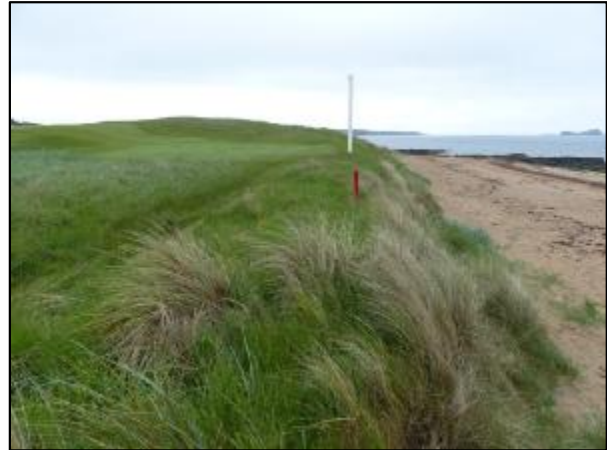
Although good stability exists through to the 3rd green, the dunes are limited to 2 m in width before the green itself and work should be considered to increase this

The dune fringe fronting the 3rd green is no more than 2 m wide and over time could become unstable, eroding with eventual loss of the green surface. The beach extends over 25 m before giving way to the rock platforms at the lower water mark.

Recommendation for Management: Ongoing management of this section of the coastline will be essential, but this will need to be backed by additional paling fencing over a nominal 60 m tract or there about using 8-10 m lengths of chestnut paling fencing installed at 60° from the north at wide 10 m spacing's. Introduce short 2 m spurs at right angles to the main runs and use buckthorn brash to further collect sand to the back of the spurs i.e. back of the junction.

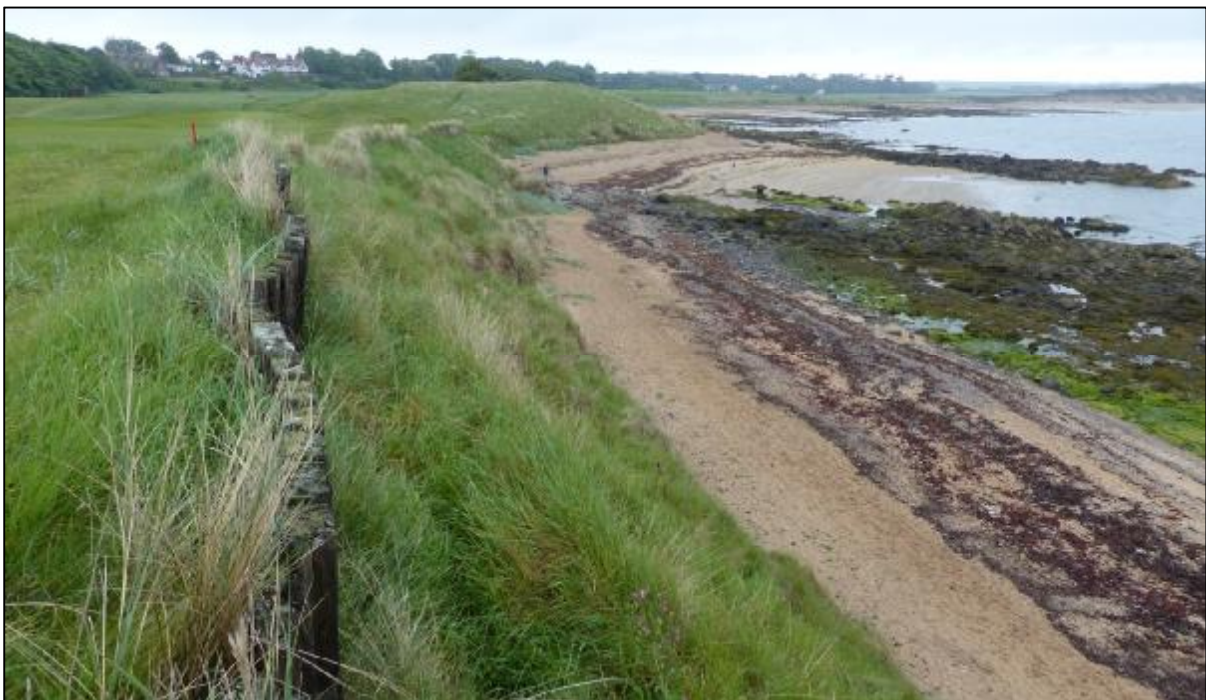
View of coastline from the left of approach

The dunes protecting the 14th are relatively tall to around 12-15 m in height, reducing to around 6-8 m through the mid-section of the fairway. The sward is becoming increasingly mesotrophic, similar to that noted right of the 3rd green, supporting perennial ryegrass, Yorkshire fog, false oat grass and cocksfoot, albeit with an increased component of marram and occasional sea lime.

A few localised access points were noted resulting in localised erosion, but these were not overly significant.

Recommendation for Management: No management other than annual monitoring through GPS surveying and fixed point photography is required. The near shore and off shore reefs i.e. the rock platforms and further out the islands are all offering good protection to this section of the bay.

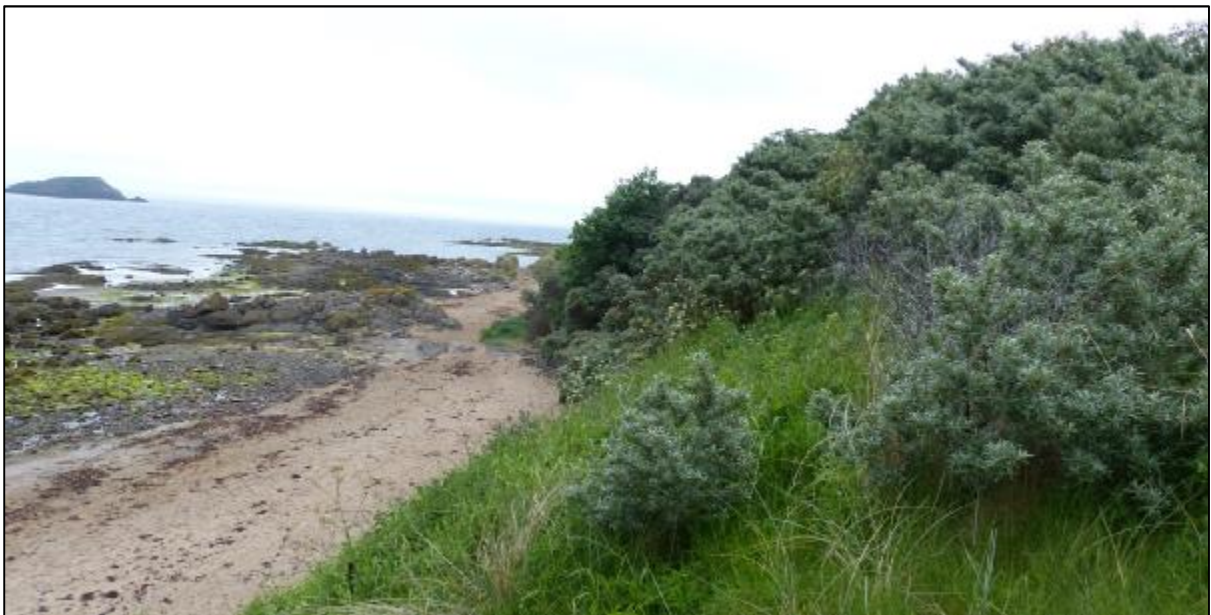
Sea-buckthorn gives additional protection and interest through the dunes running down to the coastline to the left of the 14th tees

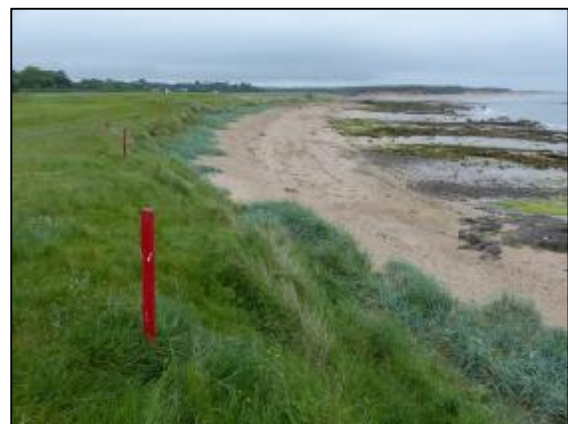
The coastal edge protecting the 13th hole was severely compromised some 10 – 12 years ago whereupon 8 m of the coastline was lost to storm damage. The resulting defences have been reduced to a nominal 12 m width of dune before the wall and the adjacent 13th hole.

Bay to the back and right of the 13th hole (running left of the 13th fairway). This bay is important as it does give protection to the 12th green.

Over the last five years, sea lime has built up to form quite a strong low level defence extending out to 4 m to the beach (18-20 m in width).

Two significant gaps between the offshore islands exist which given the more recent changes in wind speed direction is resulting in damage through this section of the bay. It would not be difficult to see here that any moderate to severe storms hitting the coastline from a northerly orientation would result in significant loss of the remaining dune system.

The dunes are highest towards the green (3 m) reducing to around 1 – 1.5 m at the lowest point i.e. adjacent to the wall.

Recommendations for Management: Introduce a series of chestnut paling fences at wide 12-15 m spacing's in an east to east south east orientation with spurs situated at right angles running in a north east to north north-east orientation.

It would be prudent to continue two or more of the paling fencings onto the dune i.e. at the lowest point and to the wall anchoring the posts well into the ground and away from the more vulnerable coastal margins. The area supporting the palings would need to be marked as GUR until a grass cover had been reinstated following sand deposition.

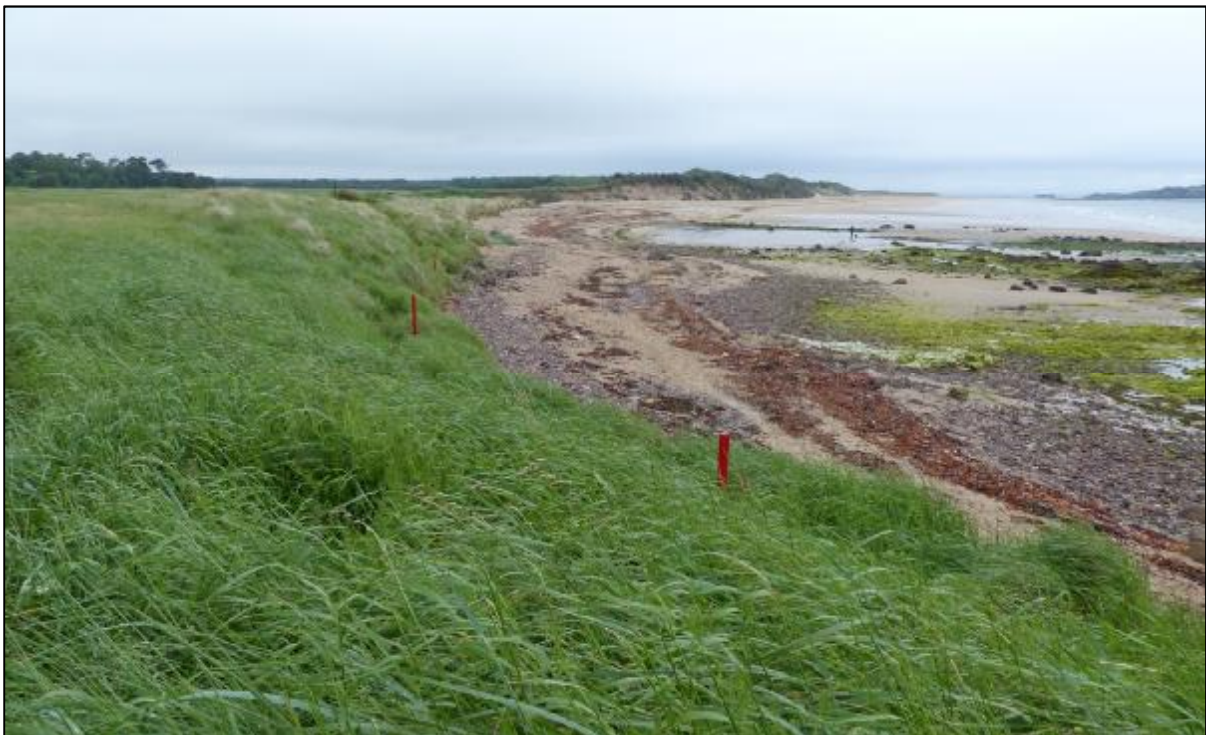
Section of coastline adjacent to the 12th hole

This section of the coastline has not changed significantly over the last 20 years which is confirmed by the presence of the red posts that earmark the out of bounds and are still in relatively the same position as they have always been with no significant loss on the coastal side.

Recommendation for Management: No recommendations for management other than ongoing annual monitoring required.

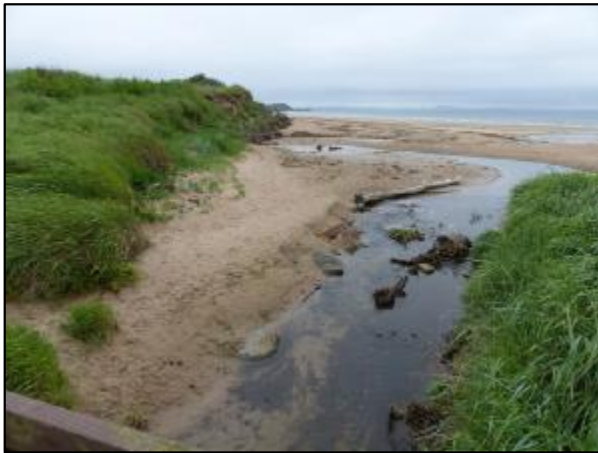
Eroding section of coastline at mouth of burn

The area due north of the open burn is prone to undercutting and coastal erosion, the dunes provide no more than 10 m of remaining protection, all of which could clearly be lost given any severe storm event. In addition, the burn remains quite dynamic and is at present undercutting the dune to the north side resulting in more significant erosion.

Recommendations for management: Given the potential for further erosion I strongly recommend that you look to create a more directed outflow to involve the following:

In the first instance it will be necessary to remove the failing gabions to the south side of the dune re-profiling and re-turfing the mound with deep turves collected from within this vicinity, whilst excavating and removing the gabions. Aim to form a 30-40 m slope staking each turf well into position. Individual turves will need to be heavily top dressed with beach sand with particular attention being given to filling in any joints to reduce drought stress and/or frost damage.

On the north side, rather than developing a solid structure it would be preferable to introduce a series of paling fences running in an east south east orientation with small 2 m spurs at right angles. The fences need only be 8-10 m in length and would need to be tied in well into the sand. Buckthorn brash would be used to bolster the palings and all wood and other debris would need to be removed. Once in place the water course can be re-orientated to run straight out to sea, the sand excavated should be stockpiled to the front and through the body of the palings to reduce visual impact and also to give an immediate start towards sand accretion and/or eventual stabilisation.

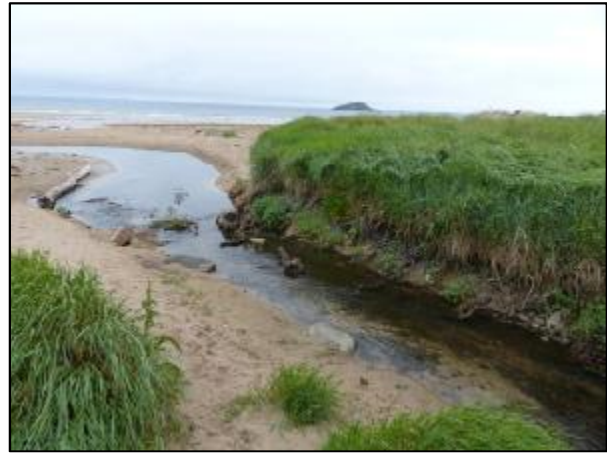
Under cutting and destabilisation of the gabions through the mouth of the burn

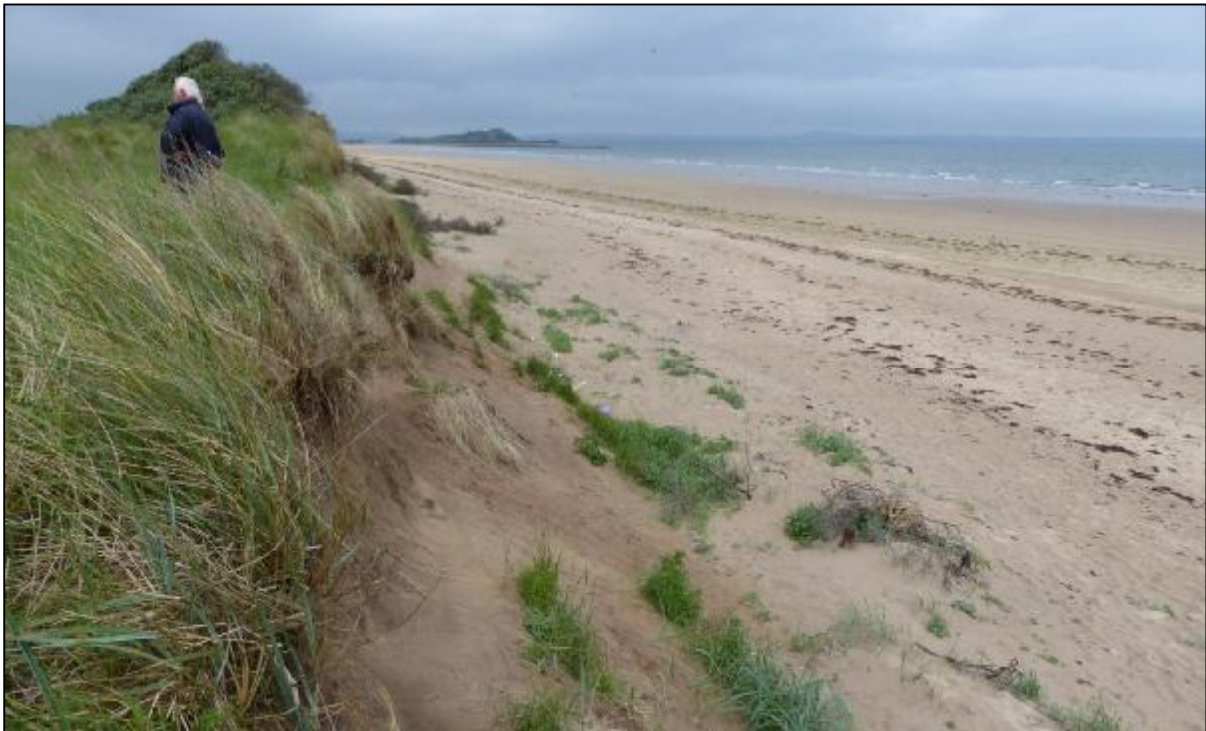
Tall dune left of the 11th green prone to undercutting and loss of vegetation

Further north, the 12th dunes are vulnerable and prone to undercutting and we agreed that soft engineered options, including the use of chestnut paling fencing would be suitable and indeed necessary, these to run over 15 m (spaced at 12 m) and positioned in a north east orientation so as to capture sand being blown from the south east and east. Continue through to where the sea-buckthorn becomes dominant and where full cover exists.
