**NORTH BERWICK  
WEST LINKS**

## Course Report – March 2023

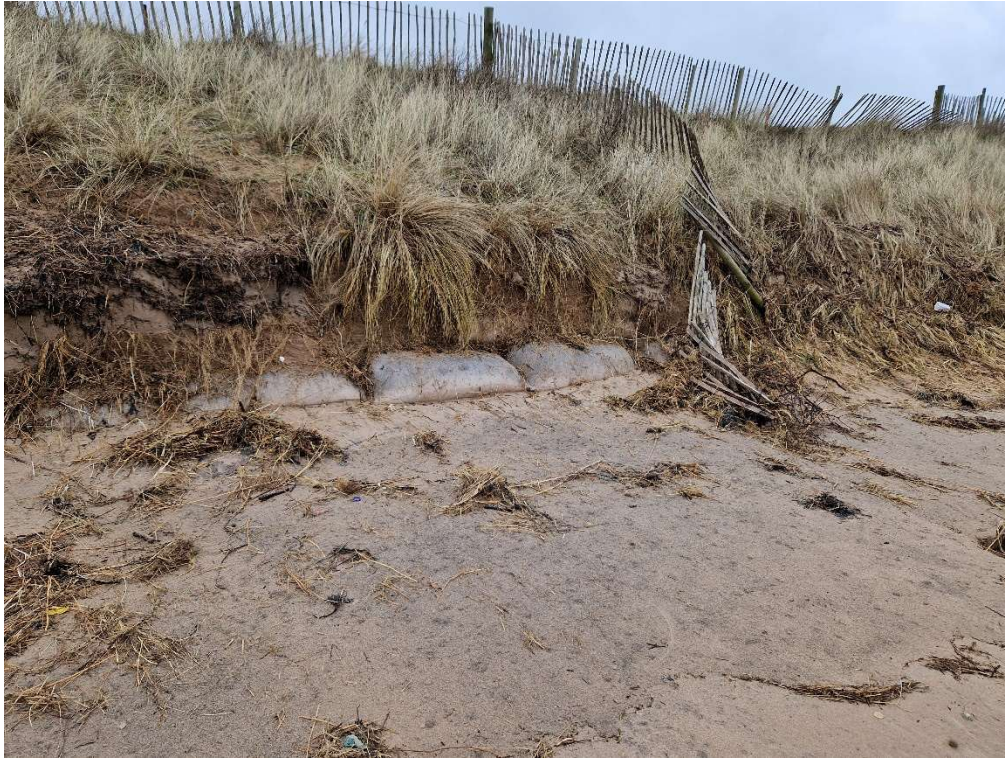
*Figure 1: The exposed sandbags at the 11<sup>th</sup> Coastal Protection area.*

The coastline along the West Links has taken another heavy hit following the recent high tides. It is concerning to see this, and it feels like the stormy weather and high tides have been relentless. We have carried out some small repairs and clearing works at the mouth of the Eel Burn and also re-covered the geotextile sandbags at the 11<sup>th</sup> green which had been exposed. If these geotextile bags are exposed for extended periods, they will start to degrade so it is important to continually monitor this area and carry out repairs when required. We have provisionally booked a contractor to come in with a digger to restore the coastline bank to an angle of 45<sup>0</sup> as was conducted in November 2023 but we are just waiting on confirming dates. We are also in continual contact with Envirocentre to make them aware of current situations to help plan for future works.

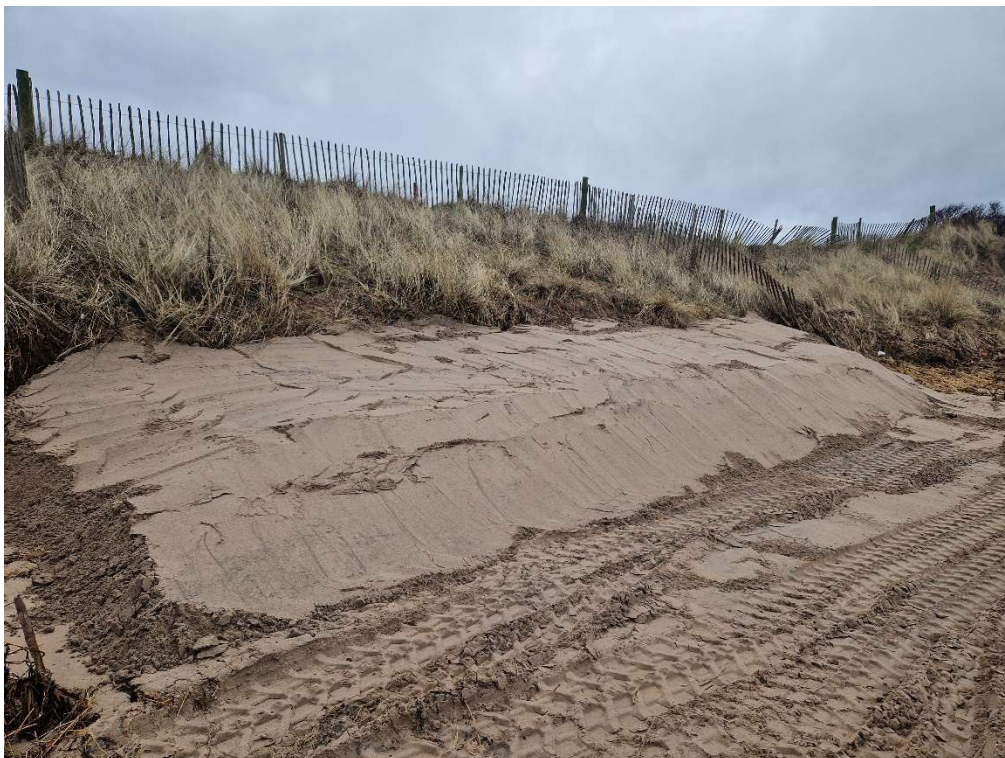
*Figure 2: The same area as Figure 1 is built up with sand to increase the protection of the sandbags. This work will be continued along the entire protection area.*

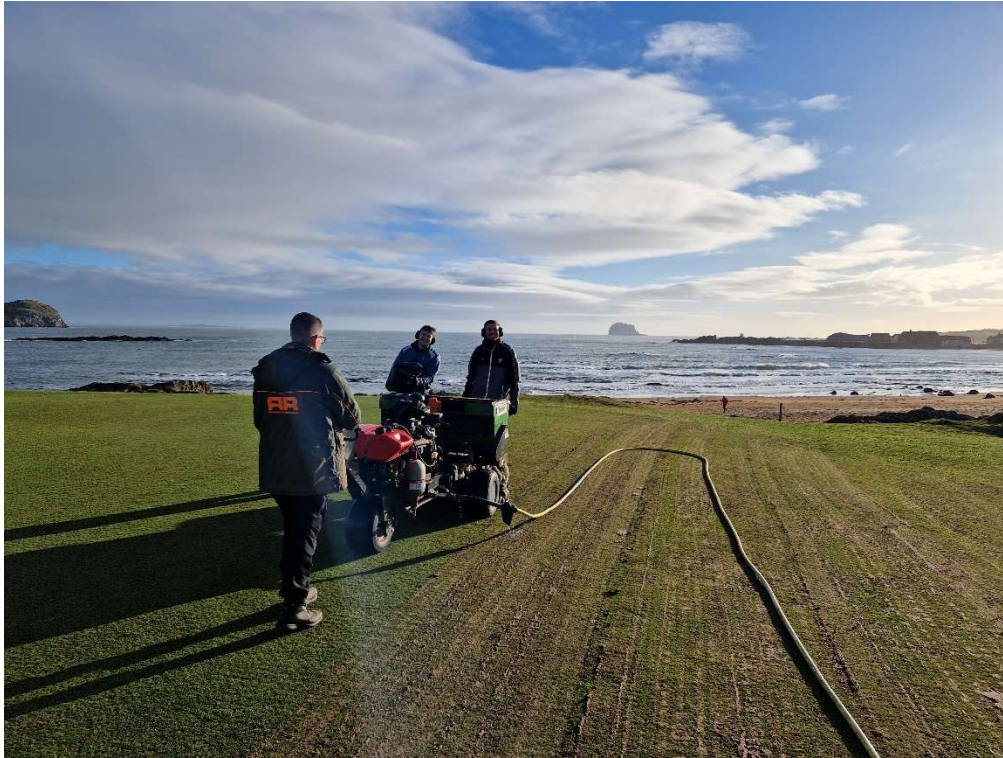
*Figure 4: Ken Siems on his Dry-Ject on the 1<sup>st</sup> green.*

The course closed on the 17<sup>th</sup> of March at 1400 for our March Maintenance Week. This gave us a chance to carry out essential work on the greens without disrupting golfers. We welcomed back Ken Siems and his son, Jacob, who used the Dry-Ject machines on the greens of the main course, the 2 putting greens and the Children's Course. This is the 5<sup>th</sup> time we have used the Dry-Ject on the greens and it has made a massive difference to how the greens perform. We have gone from an average of 12.4% of organic matter (OM) in the top 20mm on the greens in 2019 to 7.1% as July 2023 and the Dry-Ject injecting approx. 45 tonnes of sand into the profile on each visit – approx. 225 tonnes in total.

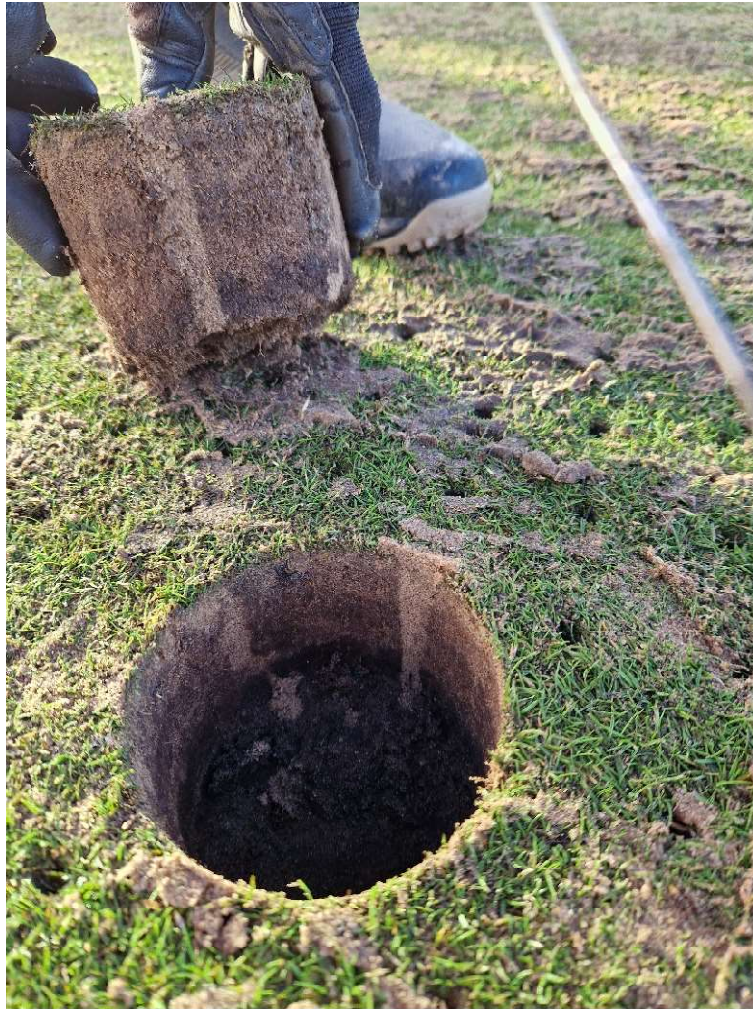
*Figure 5: An image of the sand blasted into the green by the Dry-Ject.*

- *Sunday 17<sup>th</sup> of March*
  - Greens 1-4 and 14 were Pro-Cored using 10mm solid pot seeding tines to get a good head start ahead of the Dry-Ject.
  - Fescue seed was broadcasted over these greens using a drop seeder.
  - The seed was then dragged into the pot seeding hole.
- *Monday 18<sup>th</sup> of March*
  - Greens 5-7, 11-18 & Putting Green were aerated and seeded ahead of the Dry-Ject
  - Dry-ject greens 1-7, 12-18 & Putting Green behind the Pro-Core
- *Tuesday 19<sup>th</sup> of March*
  - Finish off remaining greens with Dry-Ject (greens 8-11, Range Green & Children's Course)
  - Topdress all greens.
  - Dimple roll the greens using the Blec Multi-Seeder
  - Double roll greens in 2 directions.
  - Brush and cut fairways.
- *Wednesday 20<sup>th</sup> of March*
  - Set up course for 9/18-hole Medal.
  - Roll greens and change holes.

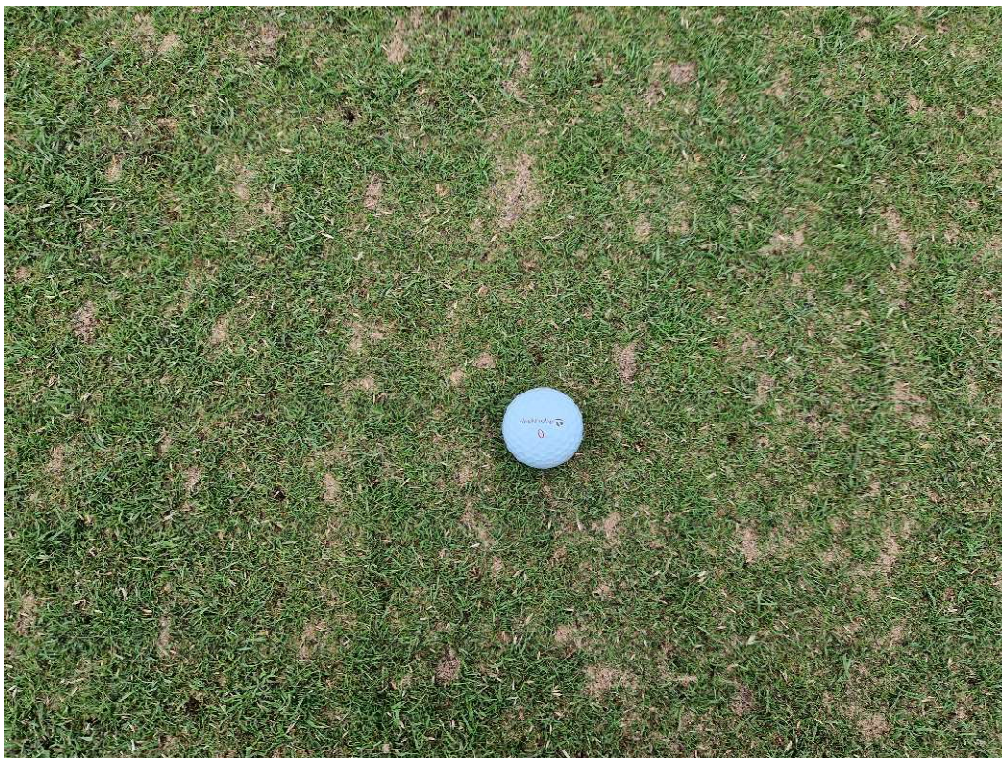
*Figure 6: The finished surface after all the maintenance works.*

We thank all members for their patience whilst this work was ongoing and recovering. We will monitor the condition of the greens following the work closely and will follow up with topdressing, fertilising or aeration works as required.
