I would firstly like to thank members for their kind words and feedback from the AGM held on the 27<sup>th</sup> of April. It really meant a lot to hear positive comments during the meeting and from speaking with members before and afterwards. I would like to reiterate my comments that full credit should go to my team who have been working very hard in some truly awful conditions since October and have really gone above and beyond to get as much work as they have completed over the winter.

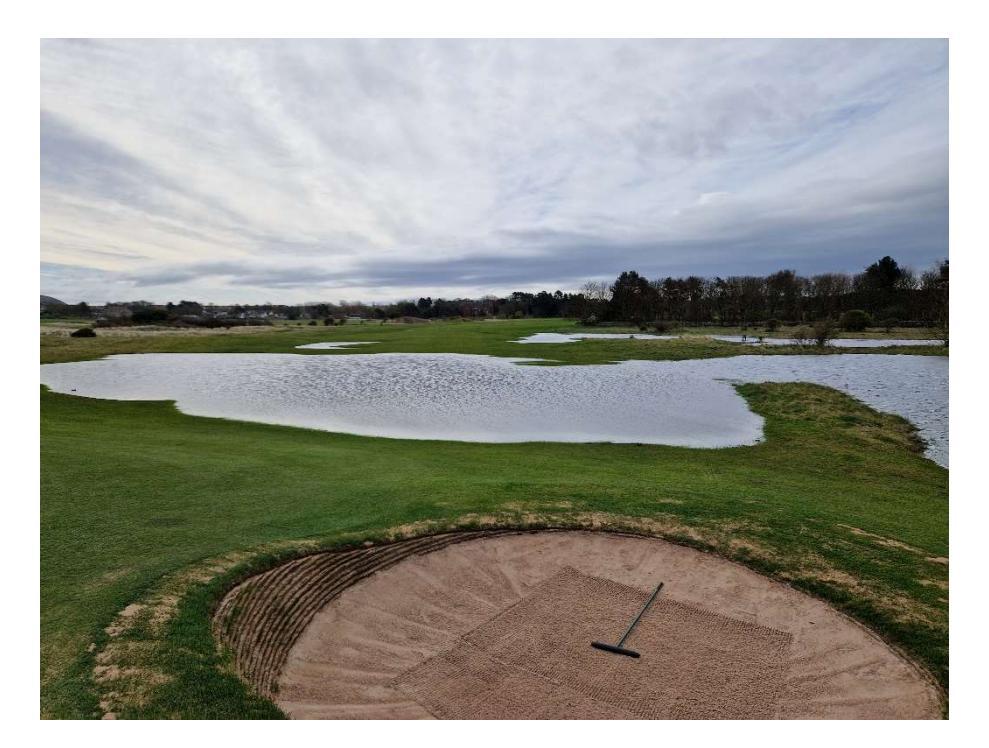
Mother Nature really hasn't given us any breaks so far in 2024 with the prolonged wet period continuing. This has been a very wet start to the month with nearly 98.2.mm to date (29<sup>th</sup> of April) which has already superseded last year's monthly total for April. We have had 2 days which have produced an inch of rain each. This volume of rain has flooded the top of the 9<sup>th</sup> fairway with water spilling over from Yellowcraigs coupled with the rising water table. There is not much we can really do at this moment with the flooded area and the water in the bunkers due to the fact the water table is so high, any effort to pump water out right now would not remove the water and would be a waste of time and labour. Of course, we will replenish the bunkers with sand and cut these areas once we are able to.

### Figure 1: Temporary water feature on 9.

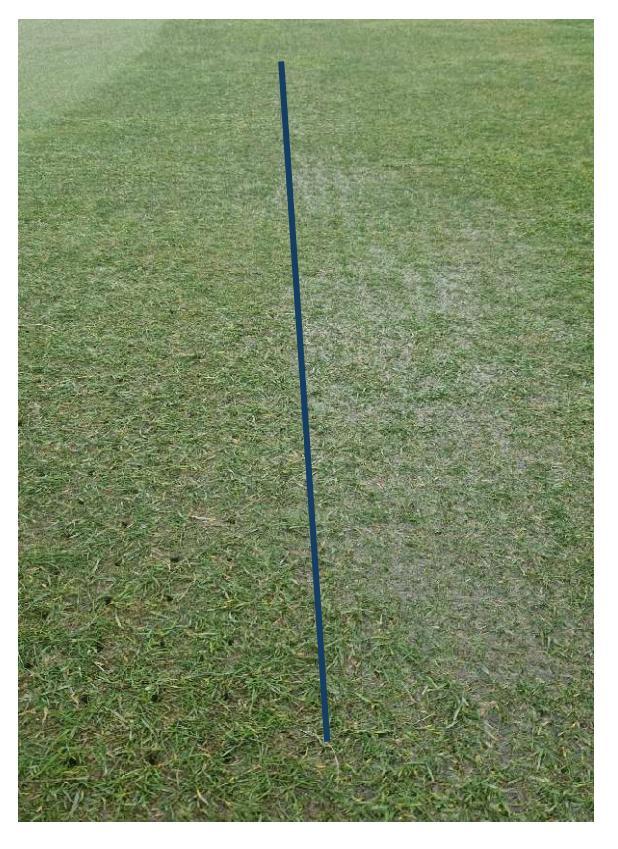
The wet conditions are part of the reason why we decided to deep tine all the greens to help filtrate water through the rootzone and avoid puddling on the surface. We started on Monday 8<sup>th</sup> and finished all the main course greens on Wednesday 10<sup>th</sup>. We tined to a depth of approx. 8 inches followed by a dimple roll to help close the holes up and to aid recovery. The below photo shows exactly the reason for doing this work with the left side of the image and area that had been tined on the edge of the green and the right side of the image

showing an area that hadn't been tined which had started to puddle and hold water. I appreciate the disruption to golfers, but sometimes we must be proactive to conditions like this.

Figure 2: The deep tining work on the left and an untouched area starting to puddle on the right.

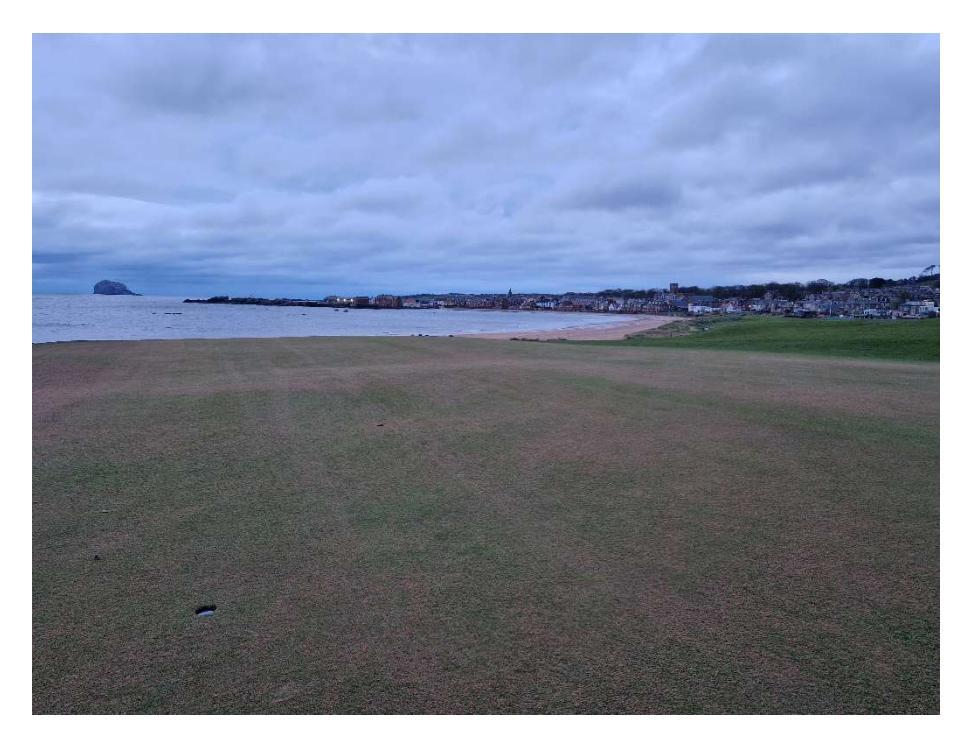
We top-dressed greens and approaches on the 15<sup>th</sup> of April which was worked into the surface well. We have spent time over the last couple of years trying to calibrate the top dresser to put out a nice even spread and we now have these settings dialed in which makes a big difference to the end result. Throughout the summer our plan is to topdress 9 holes on a weekly basis (every Monday, weather permitting) which means all the greens will receive 2 applications of topdressing per month. This should make a big difference to ball roll and consistency. The reconstruction of the Bulk Materials building last year eliminated our ability to top-dress, but now we have a good stock ready to go at any moment.

Figure 3: Topdressing on the 1<sup>st</sup> green before being dragged in.

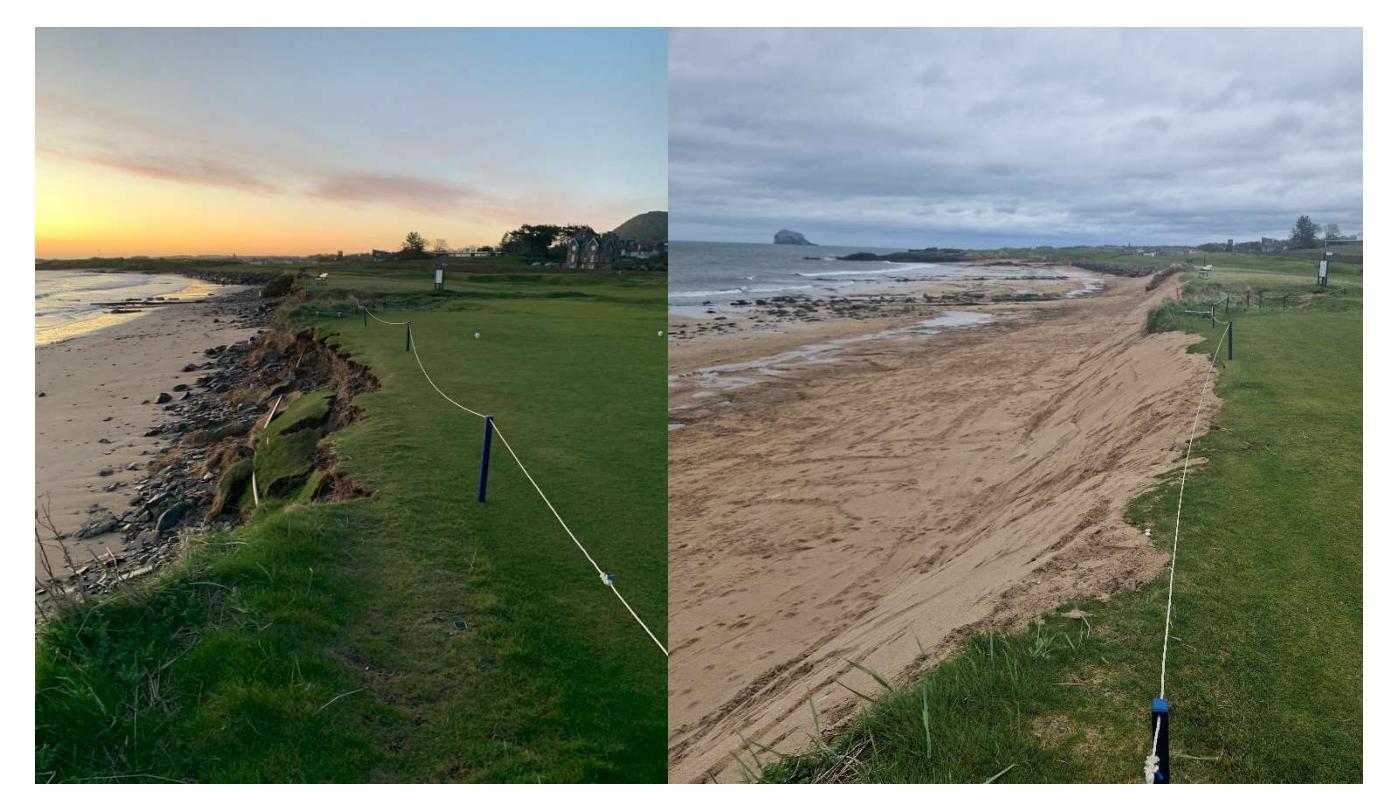
Again, Mother Nature seems to be relentless with the consistent high tides that don't seem to be easing up. We have lost more of the banking at the 3<sup>rd</sup> tee and the 14<sup>th</sup> green. The Rock Armour at the 2<sup>nd</sup> and the Sandbags at 11 are holding up well. The section that we built up with sand at the 11<sup>th</sup> has been eroded by the tides, but the sand bags have not been compromised. A local contractor carried out remedial works along the coastline by pulling back sand and rocks to fill in the eroded areas to an angle of 45<sup>o</sup> which will help to stop any undercutting and further erosion.

Figure 4: Remedial coastal erosion work at the 3rd tees
