## August Course Report

### Current Conditions

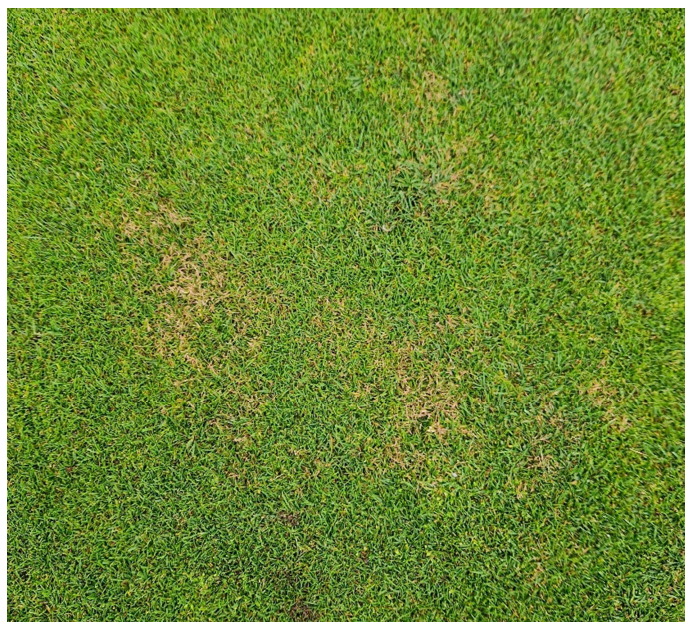
There was some disease pressure in the last month with some Red Thread; a fungal disease that is present in low fertility or nitrogen deficient turf which often is used as an indicator to apply a fertiliser which we managed to control by applying a foliar fertiliser of Ammonium Sulphate (Nitrogen source) and Ferrous Sulphate (Iron) to the greens.

*Figure 1: Red Thread on the 18<sup>th</sup> green*

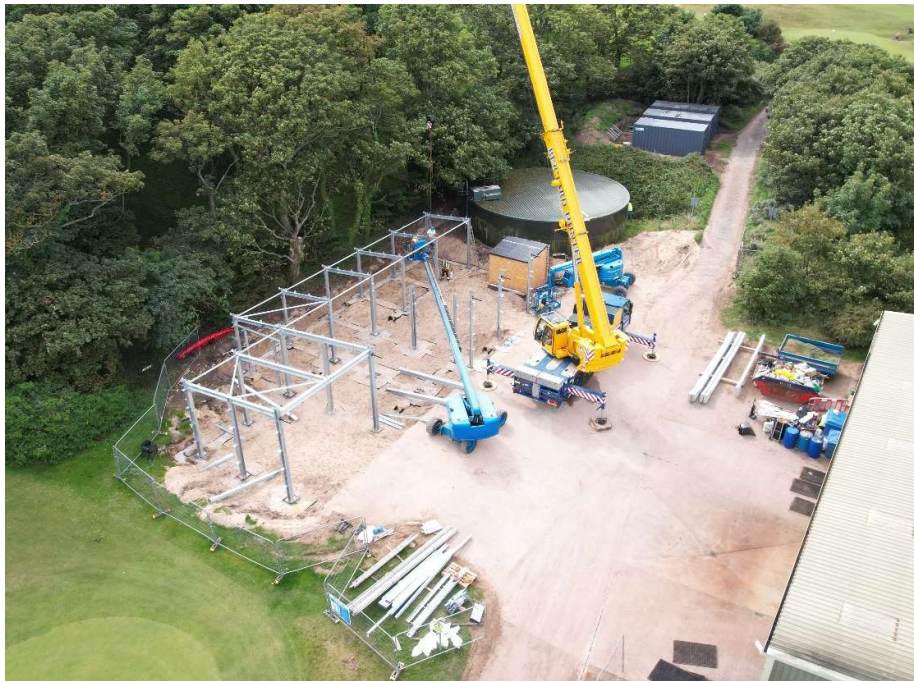
On the 14<sup>th</sup> of August, the steelwork for the Bulk Material Building arrived on site with the main pillars being installed on the same day. The crane will be onsite for a total of 3 days in which the entire steel frame of the building should be put in place. We thank all golfers and members of the public for using an alternative route whilst this work was in progress as it is not safe for people to be around the crane with very heavy steel beams being lifted overhead.

The project overall is roughly 10 days behind schedule as the contractors had issues digging out the foundations due to the sandy soil. They had to excavate down between 1300-1500mm below ground to find denser sand to pour the foundations into. The contractors are confident they will make up this time as the project goes on by carrying out some tasks simultaneously which should help them finish by their scheduled date of the 30<sup>th</sup> of October.

*Figure 2: Steel framework being installed.*

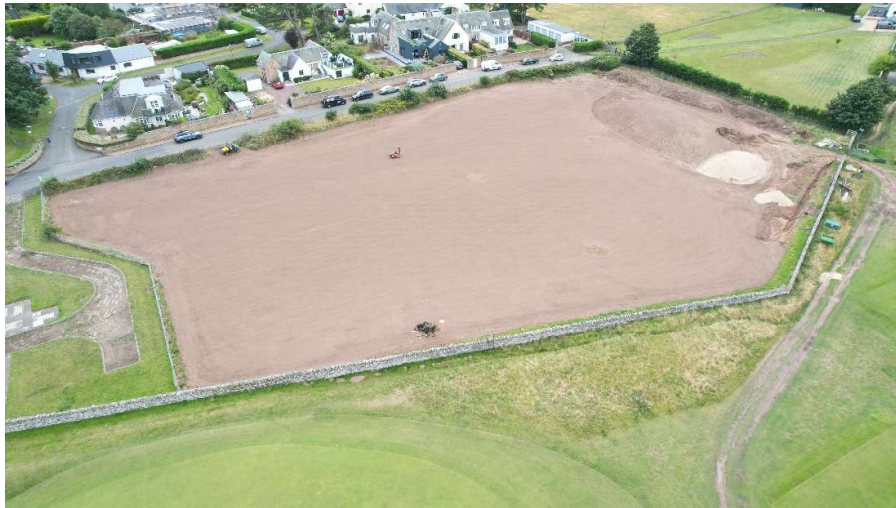
This week should see the completion of the Turf Nursery work by the contractors before being managed in-house. The large pile of soil that many of you will have seen in the nursery was estimated to be around 4200 tonnes of which we estimate we have a surplus of 1000 tonnes which can be used for other projects going forward. All of this material used has been either donated to us by 2 house extensions in North Berwick, spoil from the 17<sup>th</sup> bunker and the foundations of the Bulk Materials Building along with the existing nursery being excavated to a depth of 300mm. This has been a great sustainability project as we have not had to bring any new material in and with the surplus material that we can use for years in the future, we will be recycling/reusing material for most project work going forward.

*Figure 3: Turf Nursery being seeded by Greotech*

Greentech will finish off the project by cultivating the site, adding a pre-seed fertiliser and sowing the seed which will be a fescue mix. Once germination starts appearing, we will manage the growth by cutting the grass to increase tillering and fertilising to thicken the sward up. Irrigation will be applied throughout the day to keep the soil wet and increase the rate of germination.

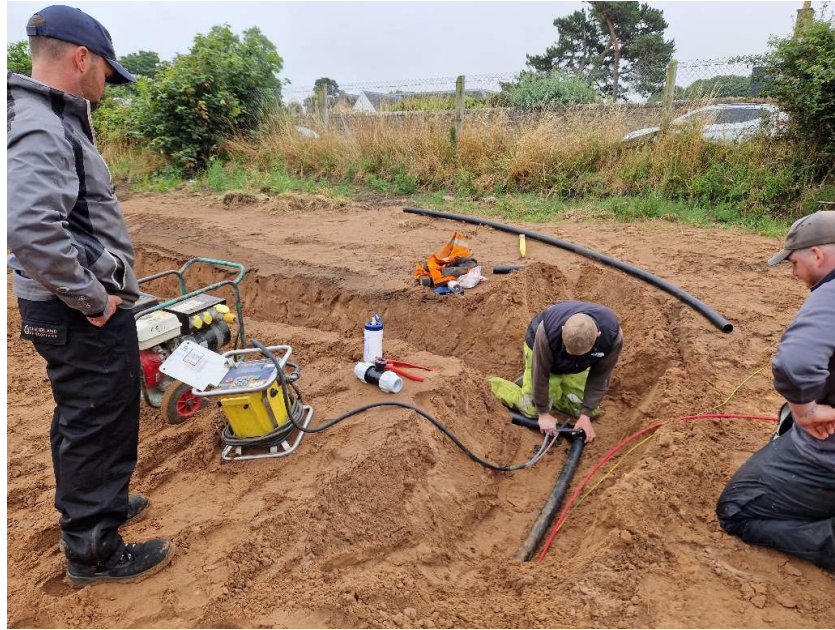
Applied Irrigation came in to install the irrigation pipework and sprinklers and trained 2 members of the team, Alex and Graeme, on how to do this. This has probably been the most satisfying part of the project, seeing 2 of the team install parts of the system so confidently with only one and a half days of training which is great experience for them going forward.

*Figure 5: Graeme and Alex learning how to fusion-weld pipes together*

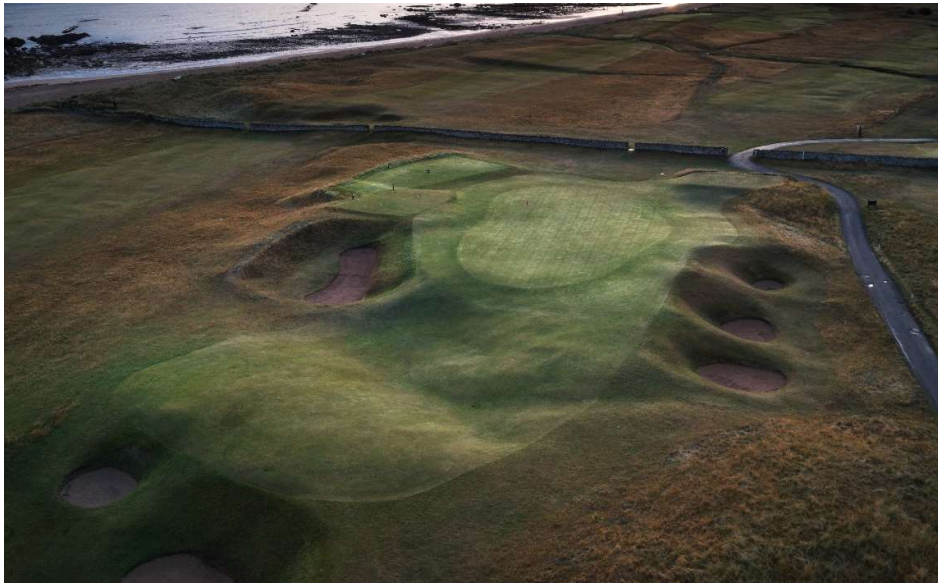
The left-hand side bunker on Redan is clearly a significant and iconic feature and we feel that it is only right that we use experts to shape and restore this bunker to how it should be. As you can see in the photo below, the bunker doesn't fit properly into its surrounding and tilts from left to right pushing all balls towards the face making it hard to play out from. The bunker will increase in size but will be more representative of what was there previously.

*Figure 8: The bunker on the left side of the green looks out of place and doesn't fit the surroundings.*
